**Report of Phase I
Environmental Site Assessment
Former Palm Springs Country Club
APNs 669-480-010 and -027,
669-590-066 and 501-190-011
2500 North Whitewater Club Drive
Palm Springs, Riverside County, California**

December 2, 2013

Project: **Former Palm Springs Country Club**
APNs 669-480-010 and -027, 669-590-066 and 501-190-011
2500 North Whitewater Club Drive
Palm Springs, Riverside County, California

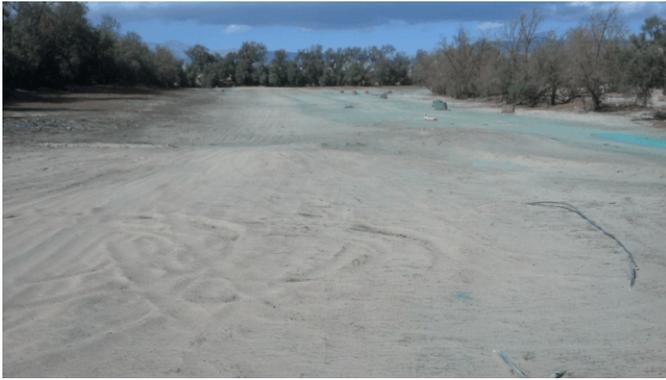
- The site was observed to consist of a former golf course and country club. Most of the site consisted of golf course fairways (Photo 1). The golf course had not been watered and the grass was dead. Much of the site had also been sprayed with a sealant for dust control. The country club buildings were located in the southeast corner of the site and had been demolished (Photo 2). Remaining hardscaped areas included concrete foundations, asphalt parking lots, tennis courts, basketball courts, entrance roads, and golf cart paths.

Photo 1: Typical view of golf course area. Note greenish color of dust control polymer.

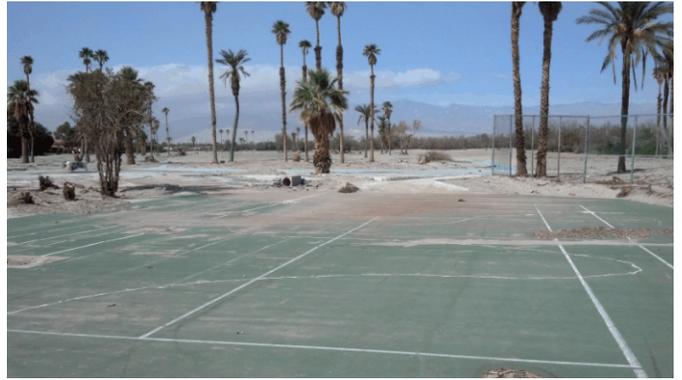
Photo 2: Former Country Club building area. Tennis court in foreground, build pads in background.

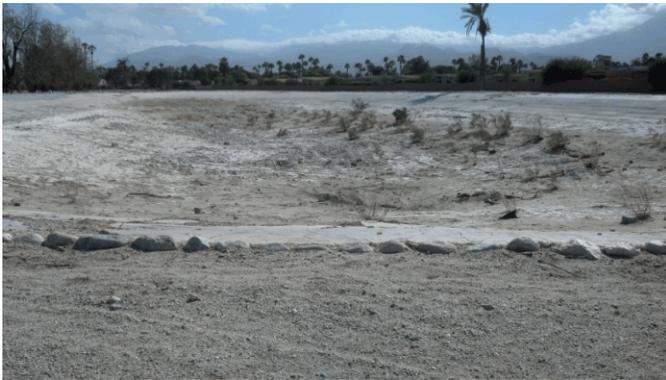
- A trash enclosure was in the southern portion of the site. Significant staining or odors were not observed.
- Two former ponds were present, both of which were dry. One had a clay bottom and one had a concrete bottom (Photos 3 and 4).

Photo 3: One of the two former golf course ponds.

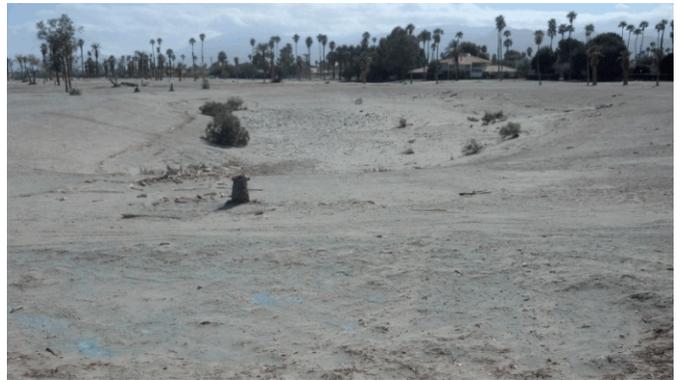
Photo 4: The second golf course pond.

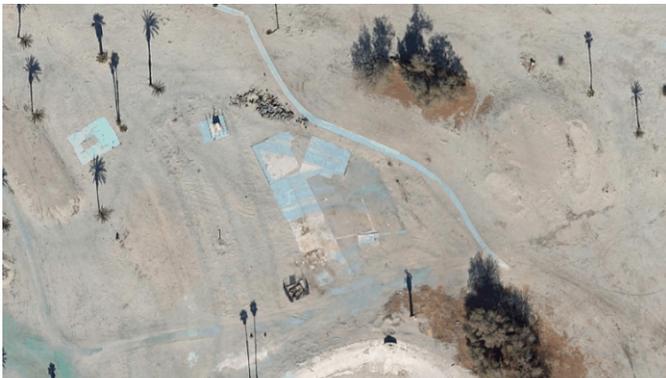
- All of the buildings at the former maintenance yard had been removed. Concrete foundations were still present, so the layout of that facility could still be discerned (Photo 5 and Figure 3). One aboveground fuel storage tank [AST] was present and appeared to be set up to store both gasoline and diesel (Photo 6). This AST was in the former location of a different AST and underground storage tank [UST] observed on the site in 1998 (ESCSC, 1998). Evidence of soil staining at the AST or around the buildings was not observed.

Photo 5: Aerial view of former maintenance yard (photo from Google Earth).

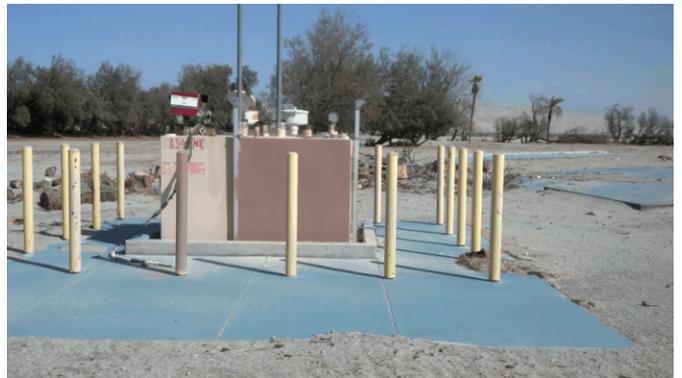
2. An above-ground fuel storage tank [AST] was observed in the former maintenance yard area. This AST was newer than the AST observed during the 1998 ESA. Evidence of spillage associated with the AST was not observed.

Photo 6: Above ground storage tank still present in maintenance yard areas.

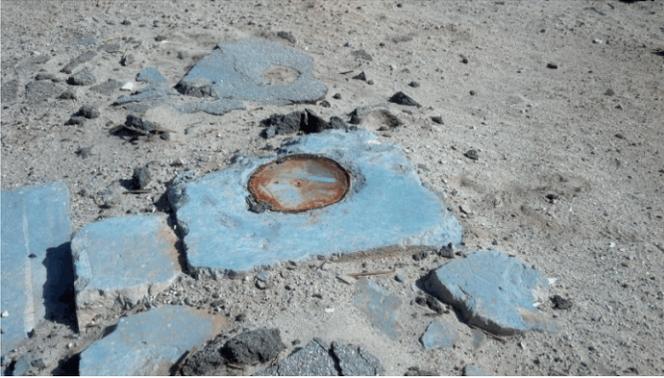
- The remnants of two water wells were observed in the former maintenance yard area (Photos 7 and 8). The pump and piping features had been removed and the wells had been capped at ground level. The water distribution piping was partially dismantled and that area was surrounded by a chain-link fence.

Photo 7: Remnant of one water well near maintenance yard.

4. The site has been used as a golf course and country club since about 1965. The site was undeveloped land prior to installation of the golf course.
5. Two water wells are located in the vicinity of the former maintenance yard, both of which have been decommissioned with the pumps removed and a cap welded over the well casing. A third feature that may be a well or may be a booster pump for the irrigation system was also observed. Wells that will no longer be in use are required to be properly destroyed/abandoned in accordance with applicable state and county

regulations. Proper abandonment would include plugging the interior of the wells and cutting off the top of the wells at least 5 feet below the final ground surface by a licensed well contractor. These wells are not considered RECs from a hazardous materials perspective.

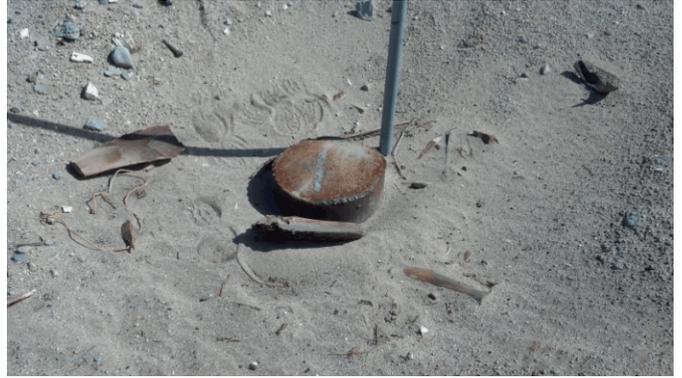
Photo 8: Remnant of second water well near maintenance yard.

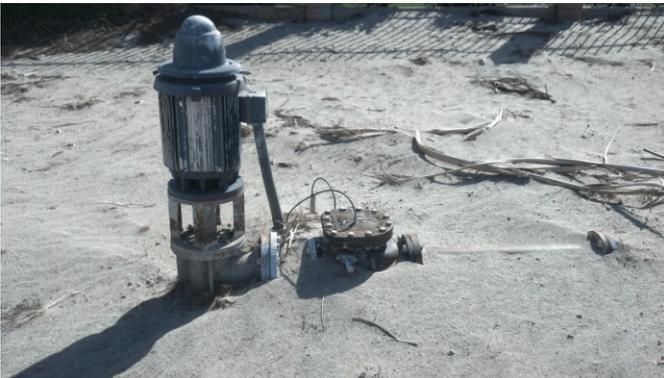
- A third feature that may be a well or may be a booster pump for the irrigation system was observed near the connection point between the northern and southern portions of the site (Photo 9). The electric motor on this feature was quite small for it to be a well, so we suspect it is a booster pump for the irrigation system.

Photo 9: Possible (A) water well or (B) booster pump for irrigation system.

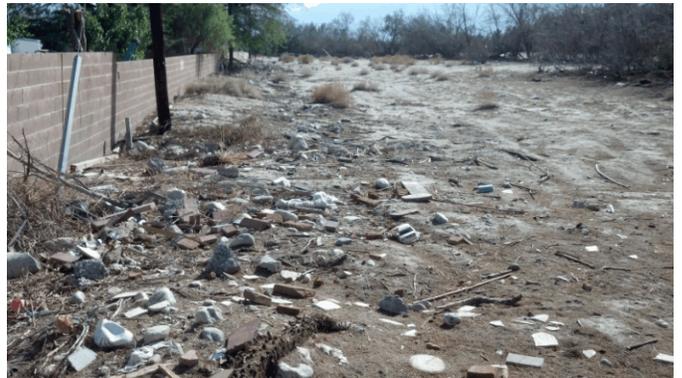
residential properties, the debris consisted of common household debris such as paper, plastic, concrete, wood and landscape waste and was likely dumped over the fence from the residential areas (Photo 10). East of the southern portion of the site, the debris consisted mostly of landscaping debris but also contained concrete, asphalt, plastic, metal parts, mattresses, tires, paper, tile, roofing material and masonry (Photos 11 and 12). Much of this debris was likely dumped by the golf course, but some of those items were probably not from the golf course. Evidence of hazardous materials was not observed.

Photo 10: Typical view of debris located along perimeter of golf course areas.

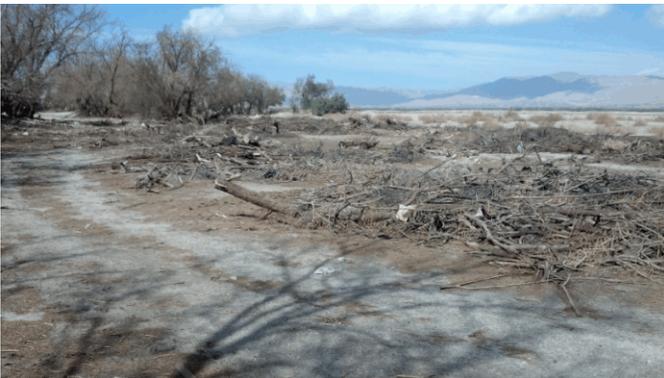
3. Landscaping debris, construction debris and household debris were noted primarily in the eastern portion of the site, and along the perimeter of the golf course landscaping. The debris does not appear to contain hazardous materials and is not considered an REC.

Photo 11: Typical view of debris in the eastern part of the southern portion of the site.

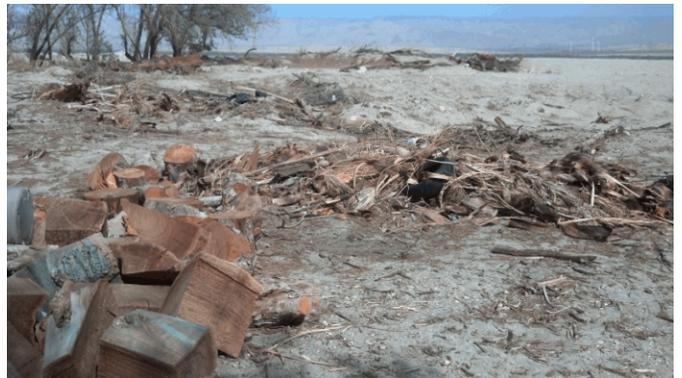
Photo 12: Typical view of debris in the eastern part of the southern portion of the site.
